**Flood Control Project Maintenance
Levee Inspections**
LMA District Cover Sheet
Spring 2018 Levee Inspection Results

Reclamation District No. 0537 Lovdal

Spring 2018 Levee Inspection Results

Waterway			Bank	Unit Miles
Unit No. 01 Sacramento River			Right	4.74
	Spring (March - May)	Summer (June - August)	(September - November) Fall	Winter (December - February)
Unit Maintenance Rating (Fall Only)				
Date of Inspection	5/1/2018 - 5/1/2018			
DWR Inspector	Zach Jojola			
Accompanied By	Oleg Yakimov DWR			
	David Julian DWR

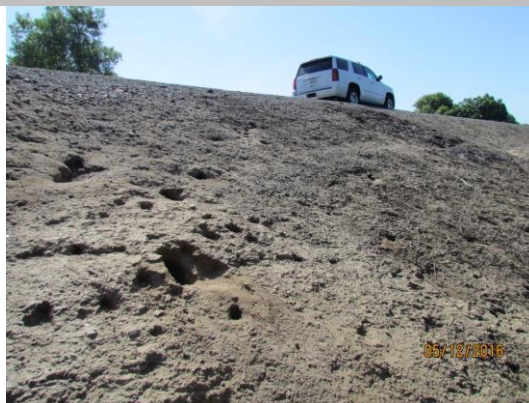
Photo 1 of 1 : SP_2018_RD0537_173_29_20180306_00023.jpg

LM Start	1.93	Rating **	M	Issue No.	29
LM End	1.95	Issue Type +	Ma	Location *	LS
Category	Earthen Levee			GPS Latitude/Longitude	
				Start	End
Item	Animal Control			38.632874 °	38.632462 °
				-121.564494 °	-121.564448 °
DWR ID	DWR_RD0537_01_f_2017_29				
Comment Code					
A3 : No rodents visible, but rodent burrows visible; need to backfill and compact or grout burrows.					
Inspector Comment

View of the rodent holes on the landward side of the levee looking downstream. Spring 2016.

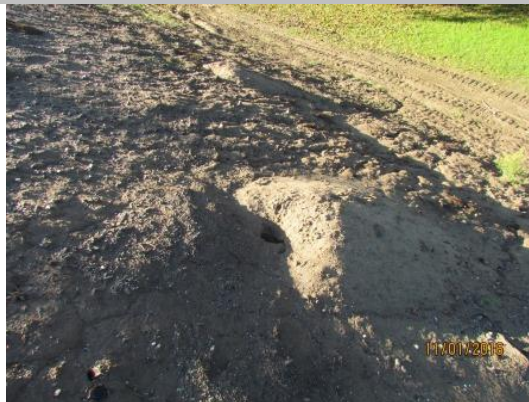
Photo 1 of 1 : SP_2018_RD0537_173_39_20180306_00035.jpg

LM Start	1.97	Rating **	M	Issue No.	39
LM End	1.97	Issue Type +	Ma	Location *	LS
Category	Earthen Levee			GPS Latitude/Longitude	
				Start	End
Item	Animal Control			38.632224 °	38.632224 °
				-121.564443 °	-121.564443 °
DWR ID	DWR_RD0537_01_f_2016_39				
Comment Code					
A3 : No rodents visible, but rodent burrows visible; need to backfill and compact or grout burrows.					
Inspector Comment					
Multiple holes on the landside slope.

Animal burrow with more than 2 cu.ft of soil out. Fall 2016.

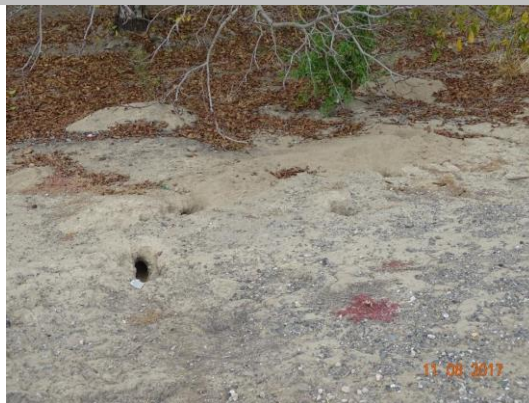
Photo 1 of 1 : SP_2018_RD0537_173_57_20180306_00056.jpg

LM Start	2.00	Rating **	U	Issue No.	57
LM End	2.00	Issue Type +	Ma	Location *	LS
Category	Earthen Levee			GPS Latitude/Longitude	
				Start	End
Item	Animal Control			38.631730 °	38.631730 °
				-121.564378 °	-121.564378 °
DWR ID	DWR_RD0537_01_f_2017_57				
Comment Code					
A3 : No rodents visible, but rodent burrows visible; need to backfill and compact or grout burrows.					
Inspector Comment					
Multiple holes on the landside slope.

View of rodent holes on the landside slope. Fall 2017.

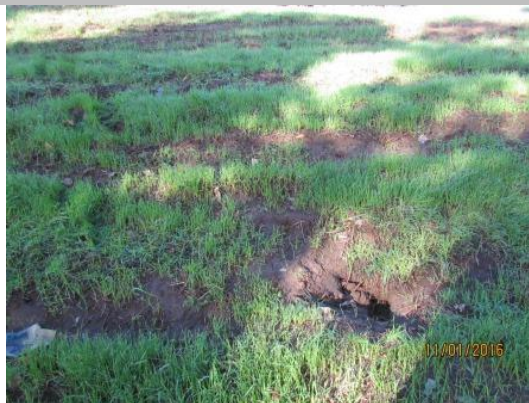
Photo 2 of 3 : SP_2018_RD0537_173_17_20180306_00014.jpg

LM Start	2.54	Rating **	M	Issue No.	17 (cont)
LM End	2.54	Issue Type +	Ma	Location *	WS

View of the rodent hole on the waterward side of the levee. Fall 2016.

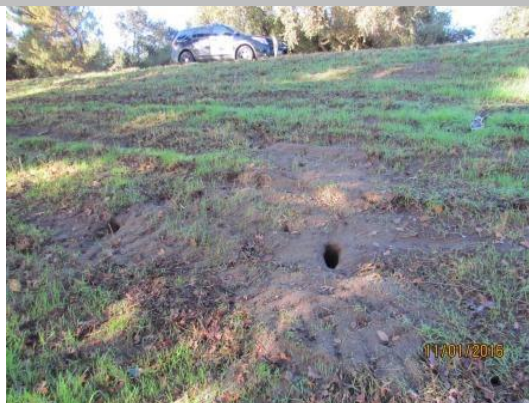
Photo 3 of 3 : SP_2018_RD0537_173_17_20180306_00015.jpg

View of the rodent hole on the waterward side of the levee. Fall 2016.

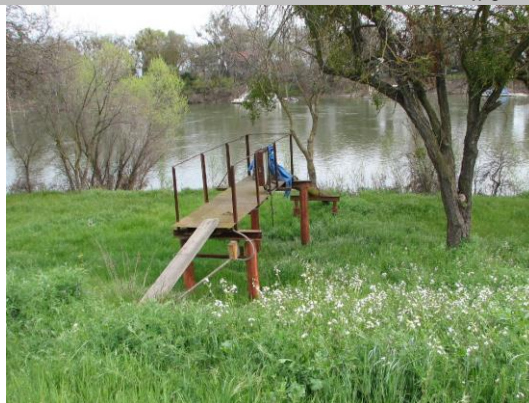
Photo 1 of 3 : UCIP_SP_2018_46035_17008.jpg

Comment Code					
Inspector Comment					
FS_ID:46035 DS_ID:178 EP_NO: N/A Repair Type: Non-Urgent Crossing Status: Found UCIP Comments: Wasted pipe and valve not visible due to vegetation. FIELD_STRUCT_DESC: 12-inch steel irrigation discharge pipe through the levee, 4.5 feet below the crown. Slant pump column on the riverbank. Timber walkway mounted on a pile structure across the waterside (WS) berm, not found. Siphon breaker in a corrugated metal pipe (CMP) riser on the landside (LS) slope. Concrete standpipe on the LS. 6-inch waste line down the WS bank with a gate valve. 2-inch electrical conduit through the levee. [Additional Reference(s): DWR Levee Log, 2004]. FS Date: 3/18/2013

WS- overview of pump, pipe and steel structure structure.

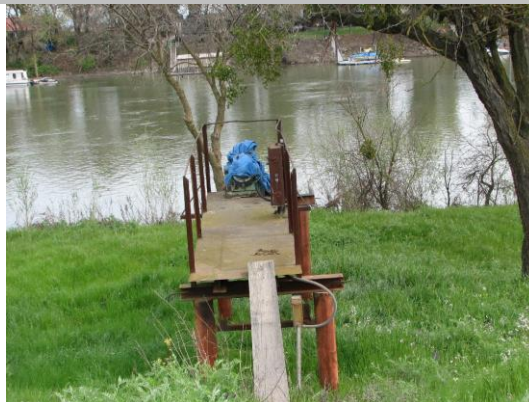
Photo 2 of 3 : UCIP_SP_2018_46035_17007.jpg

WS- closer view of pump, pipe and steel structure.

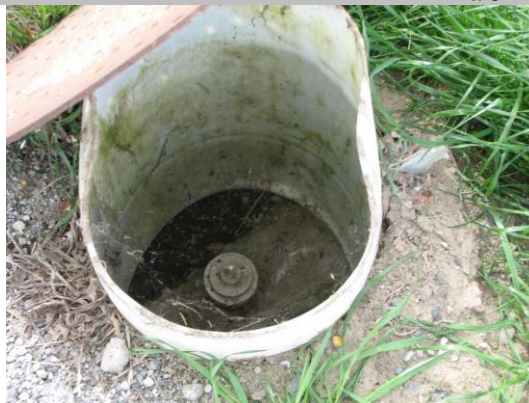
Photo 3 of 3 : UCIP_SP_2018_46035_17006.jpg

Comment Code						
Inspector Comment						
FS_ID:46035 DS_ID:178 EP_NO: N/A Repair Type: Non-Urgent Crossing Status: Found UCIP Comments: Wasted pipe and valve not visible due to vegetation. FIELD_STRUCT_DESC: 12-inch steel irrigation discharge pipe through the levee, 4.5 feet below the crown. Slant pump column on the riverbank. Timber walkway mounted on a pile structure across the waterside (WS) berm, not found. Siphon breaker in a corrugated metal pipe (CMP) riser on the landside (LS) slope. Concrete standpipe on the LS. 6-inch waste line down the WS bank with a gate valve. 2-inch electrical conduit through the levee. [Additional Reference(s): DWR Levee Log, 2004]. FS Date: 3/18/2013

LS- siphon breaker in pvc pipe riser.

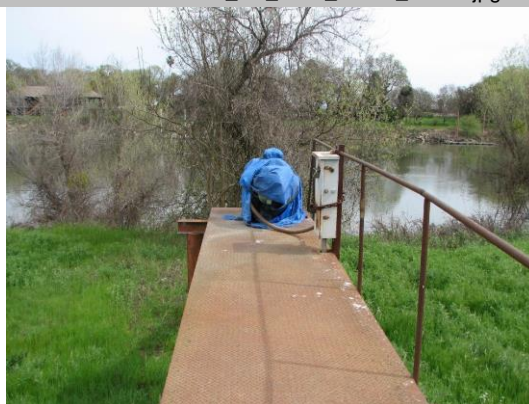
Photo 1 of 3 : UCIP_SP_2018_46037_17027.jpg

Comment Code					
Inspector Comment					
FS_ID:46037					
DS_ID:179					
EP_NO: N/A					
Repair Type: Non-Urgent					
Crossing Status: Found					
UCIP Comments: A 6-inch wasted pipe down bank, gate valve on waste line- not visible due to the vegetation.					
FIELD_STRUCT_DESC: 12-inch steel irrigation discharge pipe through the levee, 7 feet below the crown. Slant pump column on the riverbank. Steel walkway mounted on a pile structure across the berm to the pump. Buried siphon breaker in a corrugated metal pipe (CMP) riser on the landside (LS) slope. Concrete standpipe on the LS, not found; however, a shallow CMP standpipe was found on a cultivated field. 6-inch waste line down the waterside (WS) bank with a gate valve. [Additional Reference(s): DWR Levee Log, 2004].					
FS Date: 3/18/2013

WS- overview of slanted pump on steel structure.

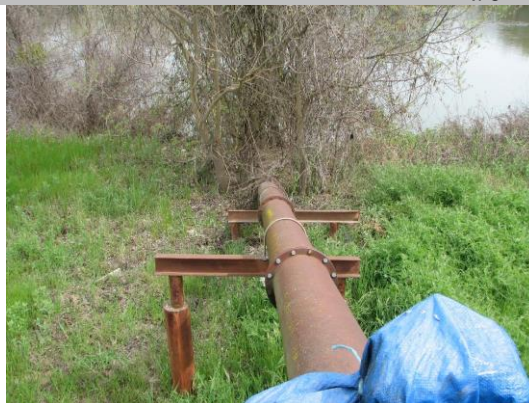
Photo 2 of 3 : UCIP_SP_2018_46037_17026.jpg

Comment Code					
Inspector Comment					
FS_ID:46037					
DS_ID:179					
EP_NO: N/A					
Repair Type: Non-Urgent					
Crossing Status: Found					
UCIP Comments: A 6-inch wasted pipe down bank, gate valve on waste line- not visible due to the vegetation.					
FIELD_STRUCT_DESC: 12-inch steel irrigation discharge pipe through the levee, 7 feet below the crown. Slant pump column on the riverbank. Steel walkway mounted on a pile structure across the berm to the pump. Buried siphon breaker in a corrugated metal pipe (CMP) riser on the landside (LS) slope. Concrete standpipe on the LS, not found; however, a shallow CMP standpipe was found on a cultivated field. 6-inch waste line down the waterside (WS) bank with a gate valve. [Additional Reference(s): DWR Levee Log, 2004].					
FS Date: 3/18/2013

WS- slanted pump and pipe on steel structure.

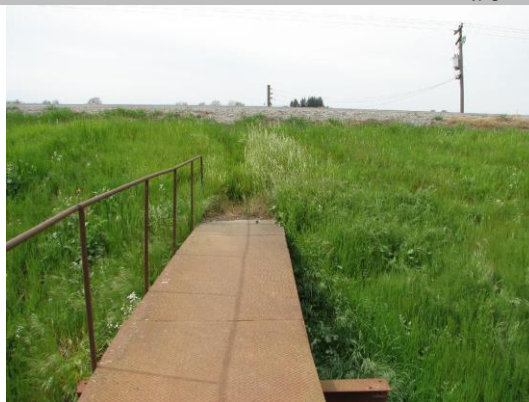
Photo 3 of 3 : UCIP_SP_2018_46037_17025.jpg

WS- steel walkway on pile structure.

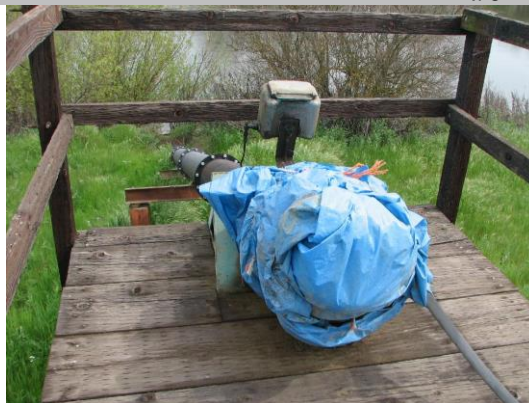
Photo 1 of 3 : UCIP_SP_2018_46806_17038.jpg

Comment Code					
Inspector Comment					
FS_ID:46806					
DS_ID:180					
EP_NO: 4656					
Repair Type: Non-Urgent					
Crossing Status: Found					
UCIP Comments: Broken gate valve handle on waste pipe.					
FIELD_STRUCT_DESC: 12-inch steel irrigation discharge pipe through the levee, 7 feet below the crown. Slant pump column on the riverbank.					
Timber walkway mounted on a pile structure across the berm to the pump. Siphon breaker in a corrugated metal pipe (CMP) riser on the landside (LS) slope. Concrete pipe riser on the LS. 6-inch waste line down the waterside (WS) bank with a gate valve. (Plans to install a new steel pipe through an existing pipe and to grout the annular space between the pipes through the levee authorized under Permit No. 4656, 1964 - Beatty H. Ramsay, MD). [Additional Reference(s): DWR Levee Log, 2004].					
FS Date: 3/18/2013

WS- slanted pipe and pump on timber structure.

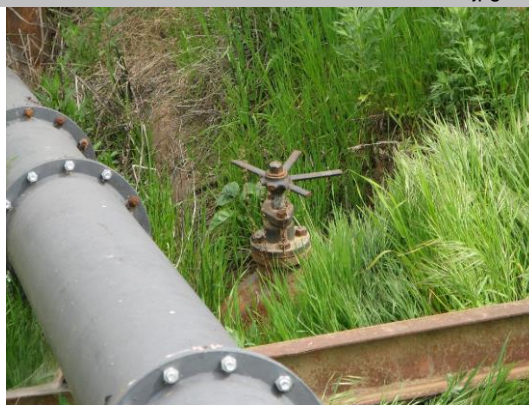
Photo 2 of 3 : UCIP_SP_2018_46806_17037.jpg

WS- main pipe and waste pipe with gate valve

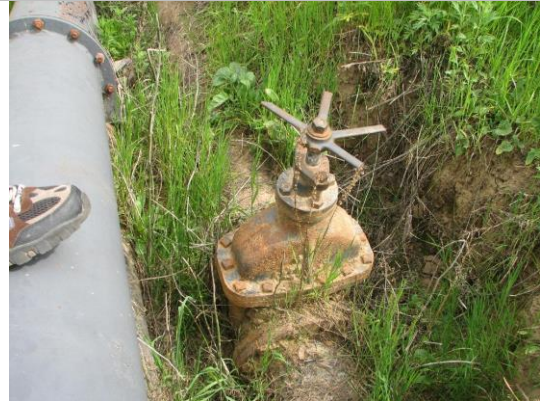
Photo 3 of 3 : UCIP_SP_2018_46806_17036.jpg

Comment Code						
Inspector Comment						
FS_ID:46806 DS_ID:180 EP_NO: 4656 Repair Type: Non-Urgent Crossing Status: Found UCIP Comments: Broken gate valve handle on waste pipe. FIELD_STRUCT_DESC: 12-inch steel irrigation discharge pipe through the levee, 7 feet below the crown. Slant pump column on the riverbank. Timber walkway mounted on a pile structure across the berm to the pump. Siphon breaker in a corrugated metal pipe (CMP) riser on the landside (LS) slope. Concrete pipe riser on the LS. 6-inch waste line down the waterside (WS) bank with a gate valve. (Plans to install a new steel pipe through an existing pipe and to grout the annular space between the pipes through the levee authorized under Permit No. 4656, 1964 - Beatty H. Ramsay, MD). [Additional Reference(s): DWR Levee Log, 2004]. FS Date: 3/18/2013

WS- main pipe and waste pipe with gate valve

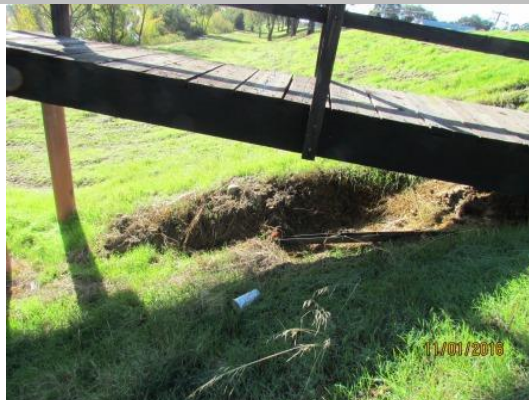
Photo 4 of 4 : SP_2018_RD0537_173_264_20180306_00067.jpg

LM Start	3.06	Rating **	M	Issue No.	264 (cont)
LM End	3.06	Issue Type +	Ma	Location *	WS
Category	Earthen Levee			GPS Latitude/Longitude	
				Start	End
Item	Erosion / Bank Caving			38.616504 °	38.616504 °
				-121.563270 °	-121.563270 °
DWR ID	DWR_RD0537_01_s_2014_264				
Comment Code					
E2 : Schedule repair of erosion site prior to the next inspection.					
Inspector Comment					
The previous erosions from Spring 2014 are corrected, however, there is erosion under the gangway.

Updated view of erosion under the gangway that is still present. Fall 2016.

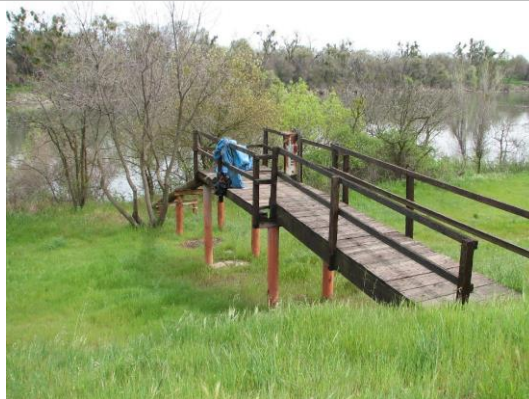
Photo 1 of 3 : UCIP_SP_2018_46041_17171.jpg

Comment Code						
Inspector Comment						
FS_ID:46041						
DS_ID:181						
EP_NO: N/A						
Repair Type: Non-Urgent						
Crossing Status: Found						
UCIP Comments: Obstructed siphon breaker.						
FIELD_STRUCT_DESC: 12-inch steel irrigation discharge pipe through the levee, 7 feet below the crown. Slant pump column on the riverbank.						
Timber walkway mounted on a pile structure across the berm to the pump. Siphon breaker in a corrugated metal pipe (CMP) riser on the landside (LS) slope. Concrete standpipe on the LS. 6-inch waste line down the waterside (WS) bank with a gate valve. [Additional Reference(s): DWR Levee Log, 2004].						
FS Date: 3/18/2013

WS- overview of slanted pipe and pump on steel pile structure

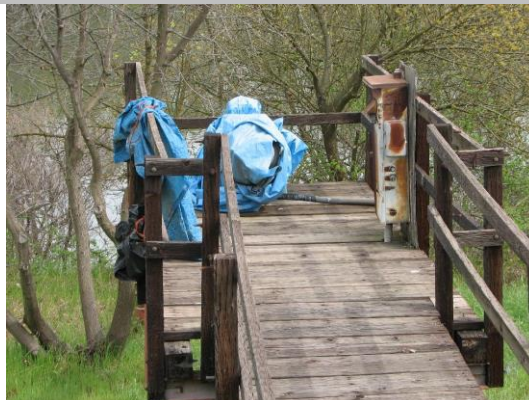
Photo 2 of 3 : UCIP_SP_2018_46041_17170.jpg

WS- covered slanted pump on timber platform.

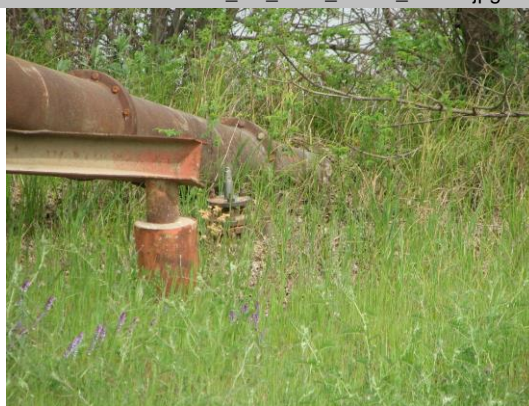
Photo 3 of 3 : UCIP_SP_2018_46041_17169.jpg

LM Start	3.06	Rating **	M	Issue No.	270 (cont)	
LM End	3.06	Issue Type +	En	Location *		
Category	Supplemental			GPS Latitude/Longitude		
				Start		End
Item	DWR UCIP Field Study			38.616413 °		38.616413 °
				-121.563205 °		-121.563205 °
DWR ID						
Comment Code						
Inspector Comment						
FS_ID:46041 DS_ID:181 EP_NO: N/A Repair Type: Non-Urgent Crossing Status: Found UCIP Comments: Obstructed siphon breaker. FIELD_STRUCT_DESC: 12-inch steel irrigation discharge pipe through the levee, 7 feet below the crown. Slant pump column on the riverbank. Timber walkway mounted on a pile structure across the berm to the pump. Siphon breaker in a corrugated metal pipe (CMP) riser on the landside (LS) slope. Concrete standpipe on the LS. 6-inch waste line down the waterside (WS) bank with a gate valve. [Additional Reference(s): DWR Levee Log, 2004]. FS Date: 3/18/2013

WS- slanted pipe and waste pipe gate valve

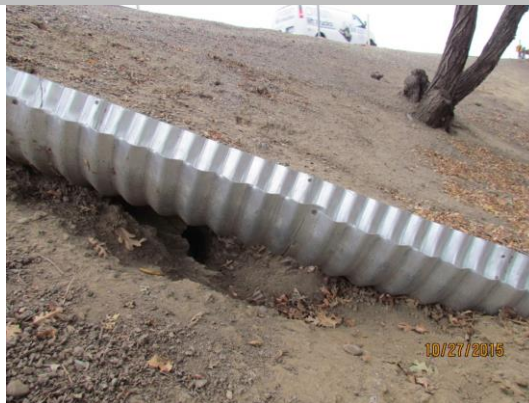
Photo 3 of 4 : SP_2018_RD0537_173_15_20180306_00011.jpg

LM Start	3.63	Rating **	M	Issue No.	15 (cont)	
LM End	3.63	Issue Type +	Ma	Location *	LS	
Category	Earthen Levee			GPS Latitude/Longitude		
				Start		End
Item	Animal Control			38.608656 °		38.608656 °
				-121.560333 °		-121.560333 °
DWR ID	DWR_RD0537_01_f_2015_15					
Comment Code						
A3 : No rodents visible, but rodent burrows visible; need to backfill and compact or grout burrows.						
Inspector Comment

There is a rodent hole under the pipe spill way. Fall 2015.

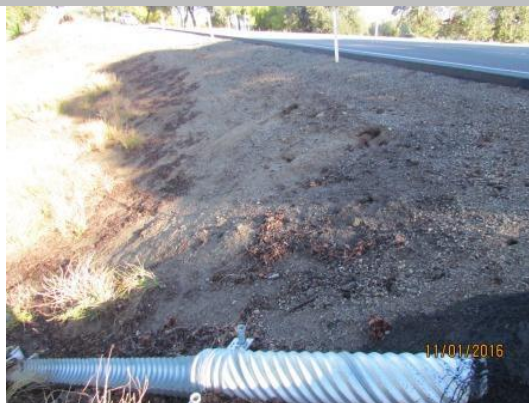
Photo 4 of 4 : SP_2018_RD0537_173_15_20180306_00012.jpg

Number of rodent holes on landside slope of the levee. Fall 2016.

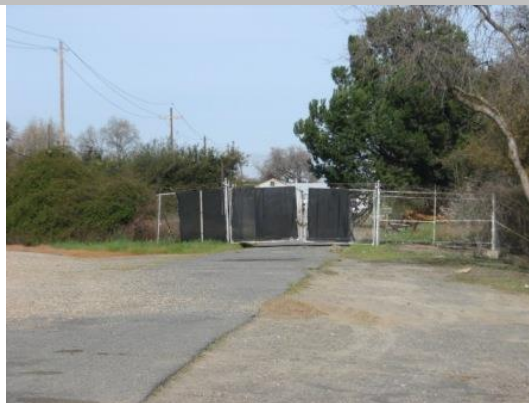
Photo 1 of 2 : SP_2018_RD0537_173_8_20180306_00006.jpg

LM Start	4.13	Rating **	U	Issue No.	8
LM End	4.31	Issue Type +	En	Location *	WS
Category	Earthen Levee			GPS Latitude/Longitude	
				Start	End
Item	Encroachments			38.602671 °	38.600687 °
				-121.555351 °	-121.553297 °
DWR ID	DWR_RD0537_01_s_2012_8				
Comment Code					
BU : Building					
Inspector Comment

Abandoned building and fence on the levee crown. Spring 2013

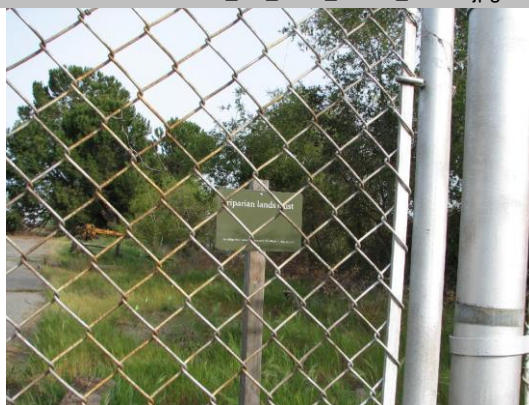
Photo 1 of 3 : UCIP_SP_2018_45026_17073.jpg

LM Start	4.24	Rating **	M	Issue No.	271
LM End	4.24	Issue Type +	En	Location *	
Category	Supplemental			GPS Latitude/Longitude	
				Start	End
Item	DWR UCIP Field Study			38.601384 °	38.601384 °
				-121.554099 °	-121.554099 °
DWR ID					
Comment Code					
Inspector Comment					
FS_ID:45026 DS_ID:171 EP_NO: N/A Repair Type: Non-Urgent Crossing Status: Indicator Found UCIP Comments: Appears abandoned and if so should be done so properly. FIELD_STRUCT_DESC: *ABANDONED* 12-inch irrigation discharge pipe of an unknown material through the levee, 15.1 feet below the crown. Pump and gate valve in a pump house on the waterside (WS) slope. Appears to be improperly abandoned. [Additional Reference(s): DWR Levee Log, 2004]. FS Date: 4/28/2015

Riparian Lands Trust- no access through gate.

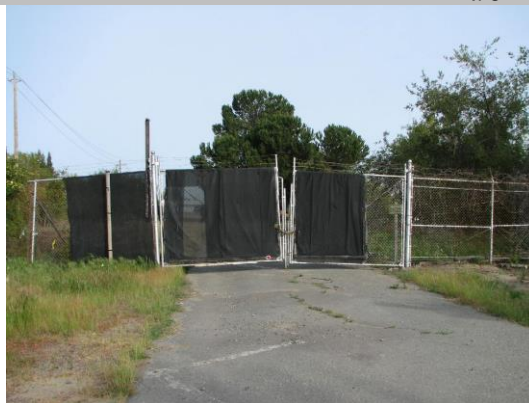
Photo 2 of 3 : UCIP_SP_2018_45026_17072.jpg

No access through gate. Area behind gated area along WS slope accessible.

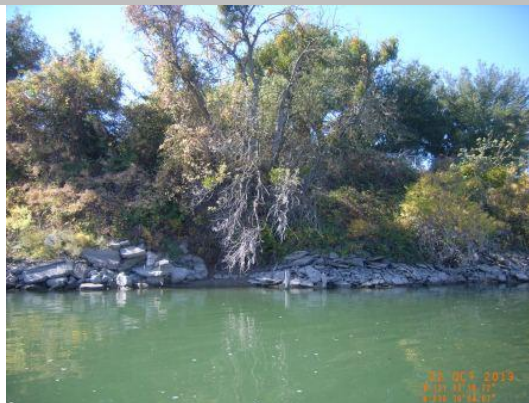
Photo 1 of 1 : SP_2018_RD0537_173_1_20180306_00001.jpg

LM Start	4.27	Rating **	M	Issue No.	1
LM End	4.32	Issue Type +	Ma	Location *	WS
Category	Supplemental			GPS Latitude/Longitude	
				Start	End
Item	2015 USACE Erosion Survey, DRAFT			38.601388 °	38.600907 °
				-121.553250 °	-121.552815 °
DWR ID	DWR_RD0537_01_s_2016_1				
Comment Code					
Inspector Comment					
1997 - This may have been a cobble rehabilitation site to the 1957 cobble that was place all the way to the I-80 Bridge. 2000 - Local damage induced by human use. 2003 - Site is still very close to the levee and into the levee toe. 2011 - One new tree has fallen. 2015: 62.9 and 63.0 have been combined into one site. [2015 Site ID: SAC_62-9_R]

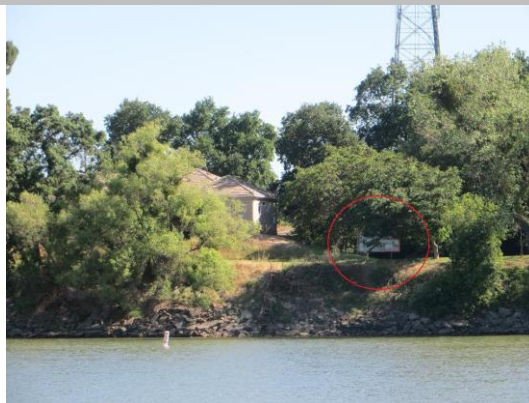
Photo 1 of 3 : UCIP_SP_2018_45024_74020.jpg

Comment Code						
Inspector Comment						
FS_ID:45024						
DS_ID:235						
EP_NO: 17993						
Repair Type: Non-Urgent						
Crossing Status: Indicator Found						
UCIP Comments: Need signs on WS slope for all gas lines in area.						
FIELD_STRUCT_DESC: 20-inch steel natural gas pipeline bored under the channel and levees, at an unknown depth. Sign on opposite bank.						
Sign off the landside (LS) toe on the other side of the railroad tracks at the base of the tower. (Plans to install a 20-inch natural gas pipeline bored under the channel and levees authorized under Permit No.						
17993, 2006 - Pacific Gas and Electric Company [PG&E], attention Michael Gunby).						
FS Date: 4/28/2015

Red circle shows location of sign on opposite bank.

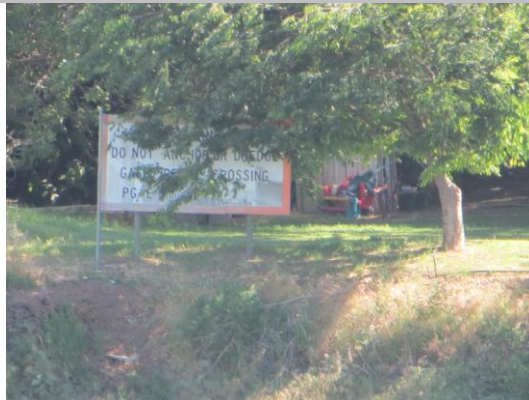
Photo 2 of 3 : UCIP_SP_2018_45024_74021.jpg

Closeup of PGE "Gas Pipeline Crossing" sign on opposite bank.

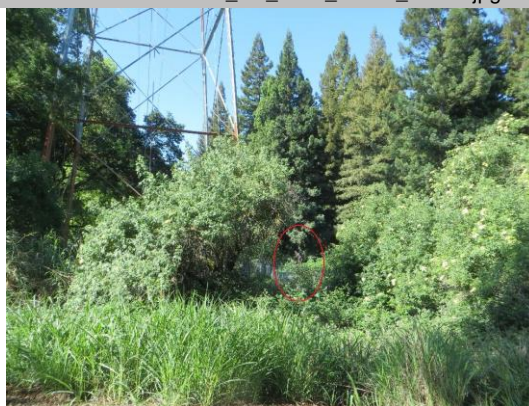
Photo 3 of 3 : UCIP_SP_2018_45024_74040.jpg

Comment Code						
Inspector Comment						
FS_ID:45024						
DS_ID:235						
EP_NO: 17993						
Repair Type: Non-Urgent						
Crossing Status: Indicator Found						
UCIP Comments: Need signs on WS slope for all gas lines in area.						
FIELD_STRUCT_DESC: 20-inch steel natural gas pipeline bored under the channel and levees, at an unknown depth. Sign on opposite bank.						
Sign off the landside (LS) toe on the other side of the railroad tracks at the base of the tower. (Plans to install a 20-inch natural gas pipeline bored under the channel and levees authorized under Permit No. 17993, 2006 - Pacific Gas and Electric Company [PG&E], attention Michael Gunby).						
FS Date: 4/28/2015

Marker off LS toe at base of tower at opposite side of RR tracks.

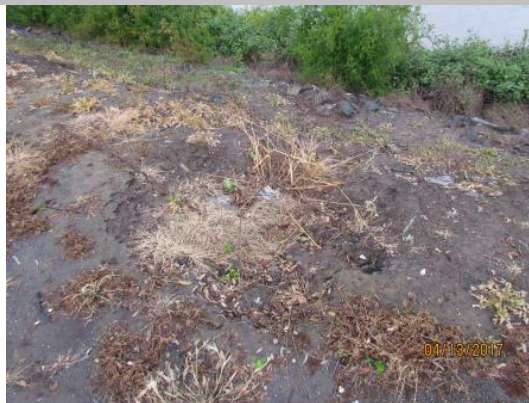
Photo 2 of 2 : SP_2018_RD0537_173_56_20180306_00055.jpg

LM Start	4.35	Rating **	A/W	Issue No.	56 (cont)	
LM End	4.35	Issue Type +	Ma	Location *	WS	
Category	Earthen Levee			GPS Latitude/Longitude		
				Start		End
Item	Erosion / Bank Caving			38.600384 °		38.600384 °
				-121.552705 °		-121.552705 °
DWR ID	DWR_RD0537_01_s_2017_56					
Comment Code						
E1 : Note and monitor erosion site.						
Inspector Comment						
Runoff erosion on waterside slope.

View of second erosion location on waterside levee slope. Spring 2017.

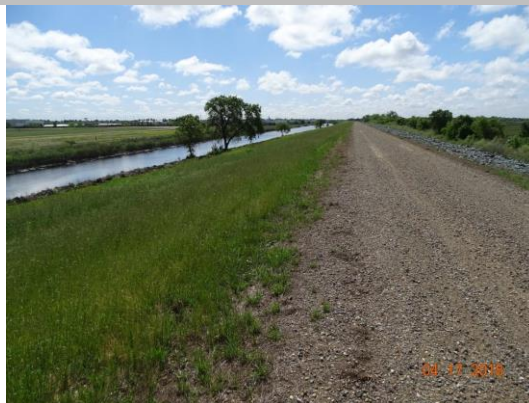
Photo 1 of 1 : SP_2018_RD0537_174_1_20180419_00002.jpg

LM Start	0.01	Rating **	M	Issue No.	1
LM End	1.16	Issue Type +	Ma	Location *	LS
Category	Earthen Levee			GPS Latitude/Longitude	
				Start	End
Item	Vegetation			38.597216 °	38.582337 °
				-121.577231 °	-121.568156 °
DWR ID	DWR_RD0537_02_s_2018_1				
Comment Code					
V1 : Control annual grass and weeds on the levee slopes and easements.					
Inspector Comment

View of vegetation on the landside slope. Spring 2018.
